## URGENT Field Safety Notice

EPIQ Elite v14.0 Software Issue with C5-1 Transducer

AUG-2026

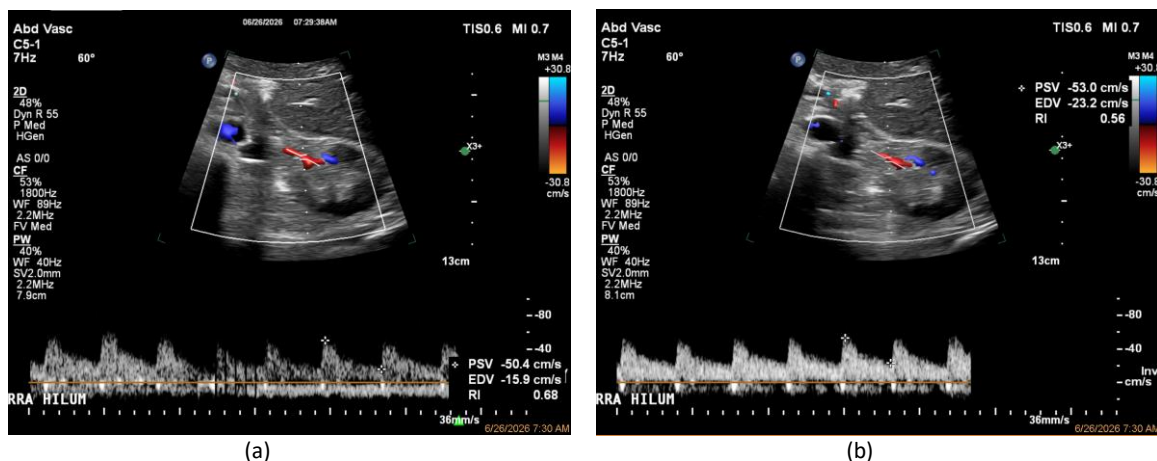
When using a Philips EPIQ Elite system with the C5-1 transducer with the Abd Vasc TSP in Pulsed Wave Doppler mode, the visual representation of the Pulsed Wave sample volume (SV) gate is slightly offset (shallower) to the actual location of the Pulsed Wave measurement. Under default conditions, it will result in an approximate 2mm offset. In larger vessels, the defect may result in reduced signal, which the user may compensate for by increasing PW Gain on the system. In smaller vessels or stenotic flow, the defect may result in underestimation in severity of stenosis. This issue could result in delayed diagnosis or treatment. Inaccurate data may lead to misdiagnosis and incorrect treatment decisions if not identified or corroborated with other diagnostic tools.

Figure 1: Example with small vessels. (a) Ideal Positioning - SV placed near center of vessel lumen. Weaker amplitude signal with PSV of 50.4cm/s. (b) Positioning Offset - SV placed slightly posterior to the vessel resulting in a stronger PW Doppler trace. PSV of 53.0cm/s.

- Due to possibility of a weak PW Doppler Signal on EPIQ Elite running 14.0 SW, customers are advised not to use C5-1 Abd Vasc Tissue Specific Preset (TSP). Please use a different TSP (e.g., Abd Gen, Abd Renal) within C5-1. Please note that this issue (i.e., Weak PW Doppler signal) is restricted to the Abd Vasc TSP with C5-1 on EPIQ Elite running SW 14.0 only.
- Otherwise, you may continue to use your device in accordance with the IFU.
- Circulate this notice to all users of the device so that they are aware of the product issue and associated hazard / harm.
- Post this notice near the affected unit(s) for ease of reference

Philips will be implementing a software correction free of charge to address the issue.
