## **IMPORTANT PRODUCT NOTICE**

7 December 2023

RE: Roadmap pro dark image

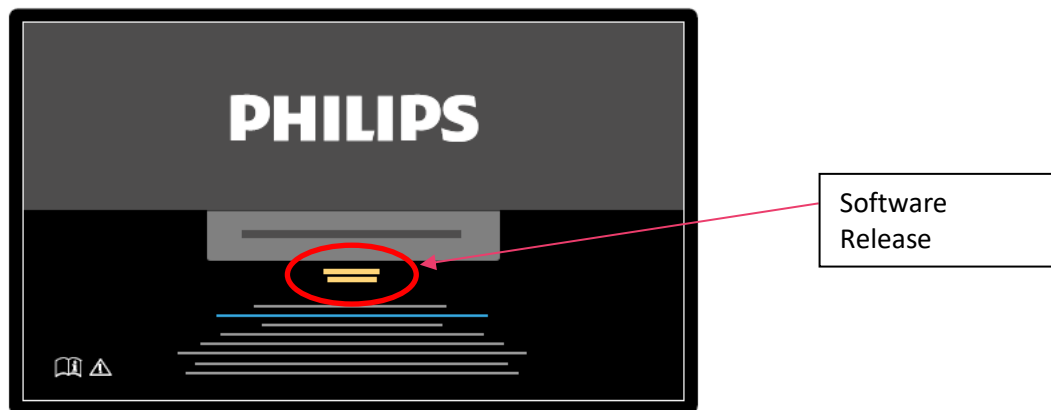
Figure 2: System start-up screen

The software version of the Philips Azurion system can be identified during start-up (Figure 2).

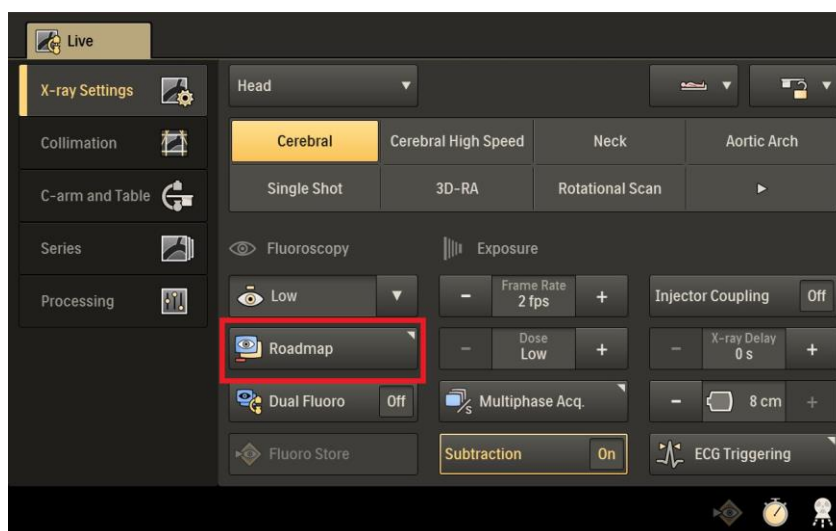
Figure 3: System with Roadmap Pro

The availability of the Roadmap Pro functionality can be identified on the Touch Screen Module (TSM) (Figure 3).
