## URGENT Field Safety Notice

EPIQ Elite v14.0 Software Issue with C5-1 Transducer

AUG-2026

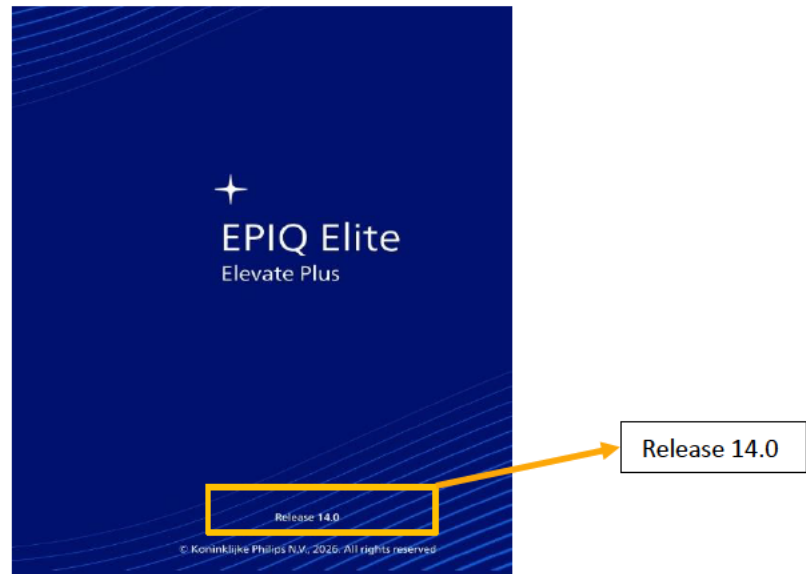
*Figure 3 Software Version*

- A. To determine if your EPIQ system is operating with version 14.0, utilize one of the following two methods:
  1. The software version will be displayed on the splash screen during the system boot up as shown in Figure 3.
